Sketch showing for replacement of broken poles 03 nos 9m PSC and 1 nos 9m RCC by good poles at Malasavara Village due to heavy wind and rain tree fallen on the existing Malasavara feeder 11kv line in arehalli section.  
(near Side RR no-MS94)

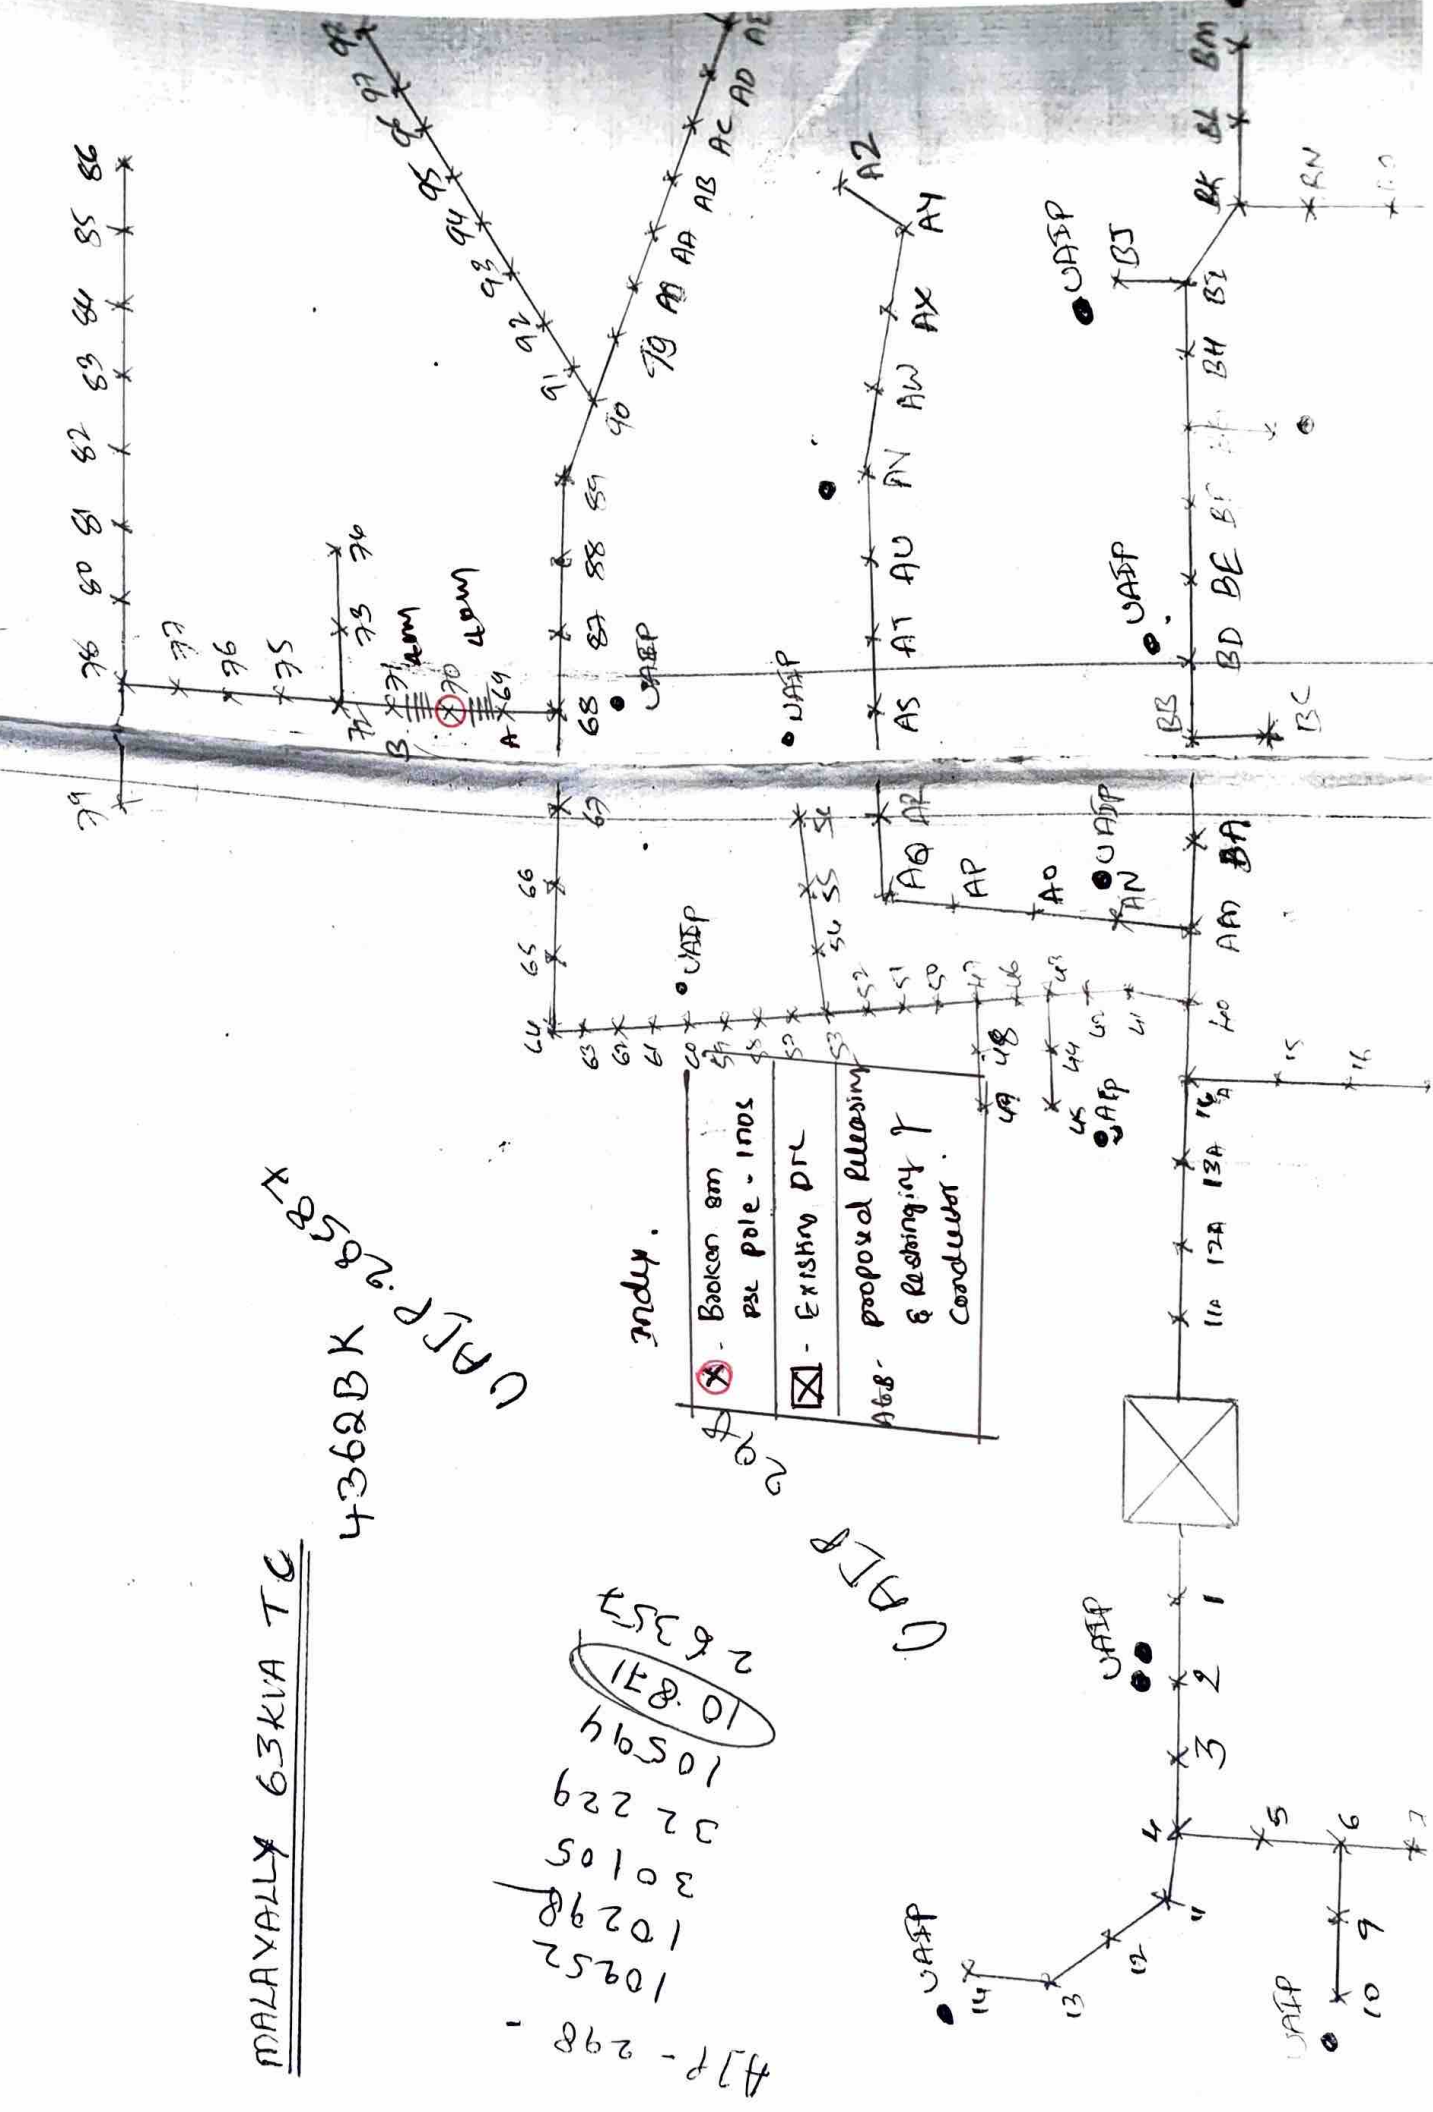
— X —	Existing HT Line
□ X	Broken pole need to replaced - 9m RCC pole
— A — B	Proposed releasing & Restraining of conductor
⊙ X	Broken pole need to replaced - 9m PSC pole

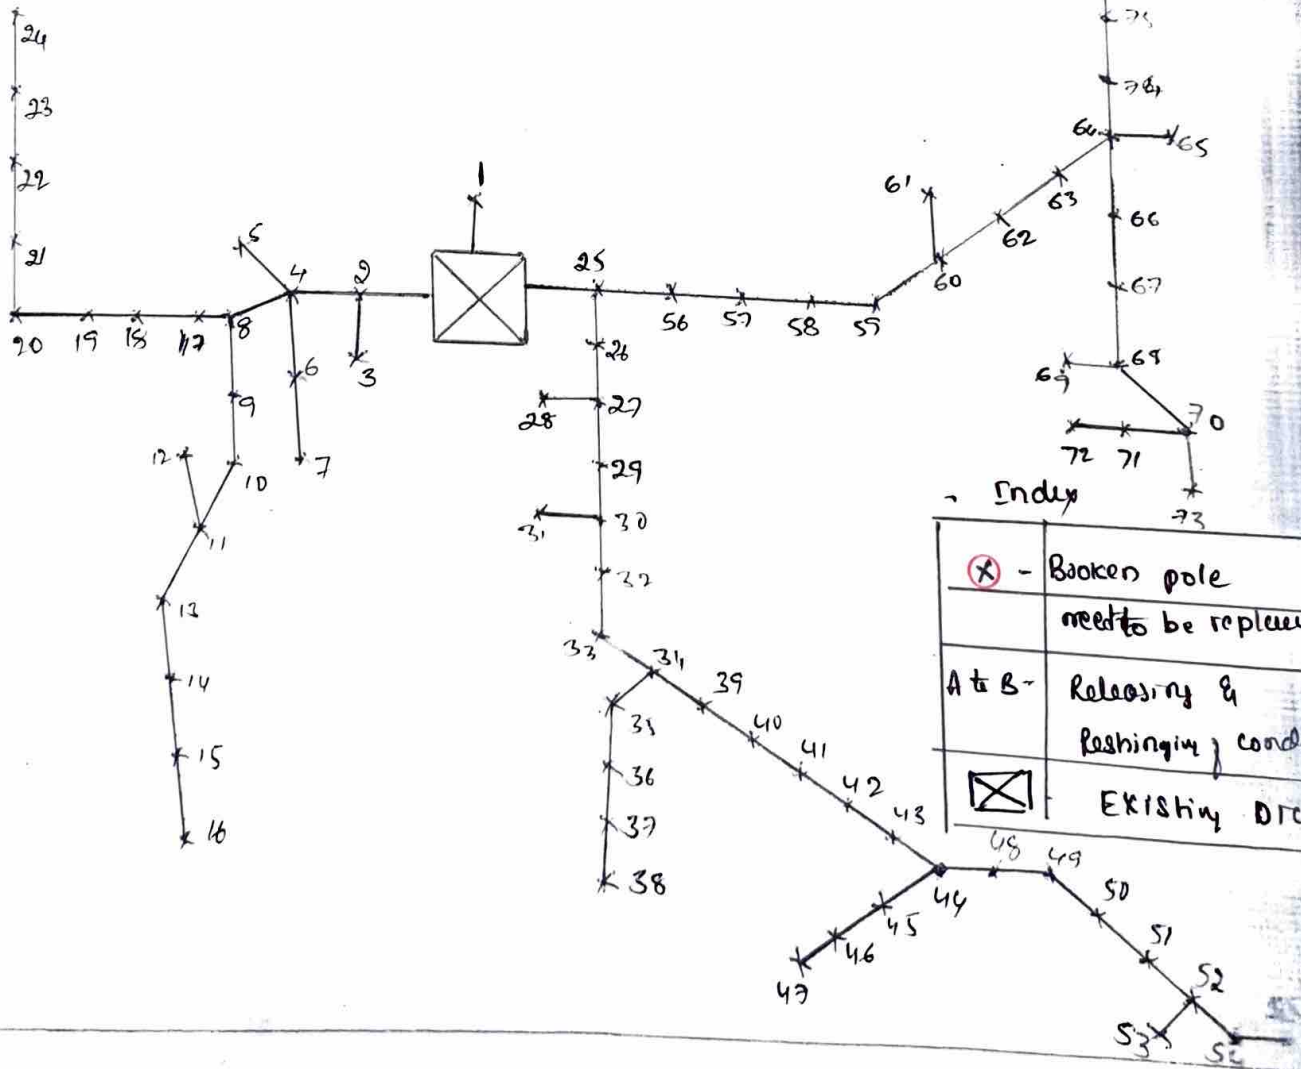
(X)	- Broken pole needs to be replaced
A to B	- Releasing & reshinking conductors
(Square with X)	- Existing DTC
