Sketch showing for replacement of broken or 9m pole & 01 nos psc poles at Deepak Saldan Estate, due to Heavy wind & Raining at Nore Village Aurhulli section.

Sketch showing for replacement of broken 1 nos 9m RCC pole due to heavy wind and rain tree fallen on the existing Kesagodu feeder 11kv line at Mogasavara village limits in arehalli section.
 (near Side RR no-~~010005~~) MGVL-18

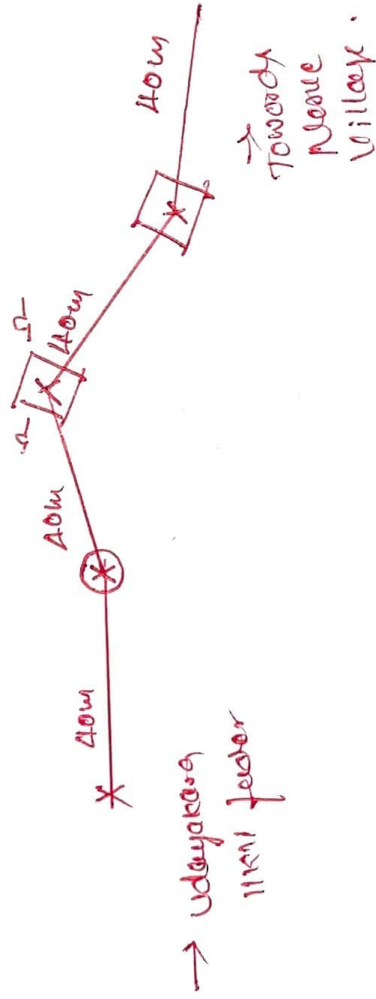
-*	Existing 11KV line
⊗	proposed replacement of broken 9m psc pole
⊠	proposed replacement of broken 9m pole
Ω	proposed Guy wire

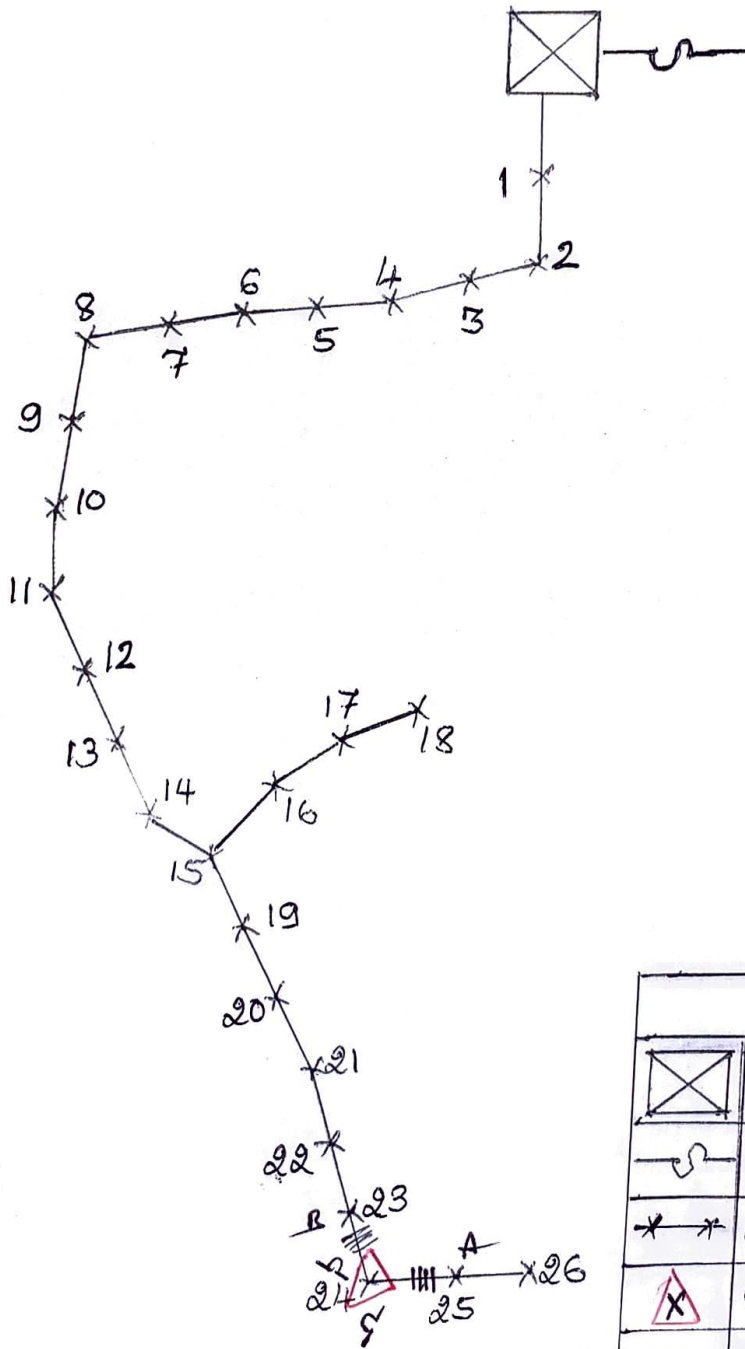
LOCATION :- Anthoni Estate

INDEX	
	EXISTING 25KVA TRANSFORMER
	EXISTING 11KV D.O.L.
	EXISTING LT WIRE 3Ø
	Broken pole need to be replaced (8m)
	proposed Guy wire (8m)
	proposed Releasing & Restoring of Conductor.

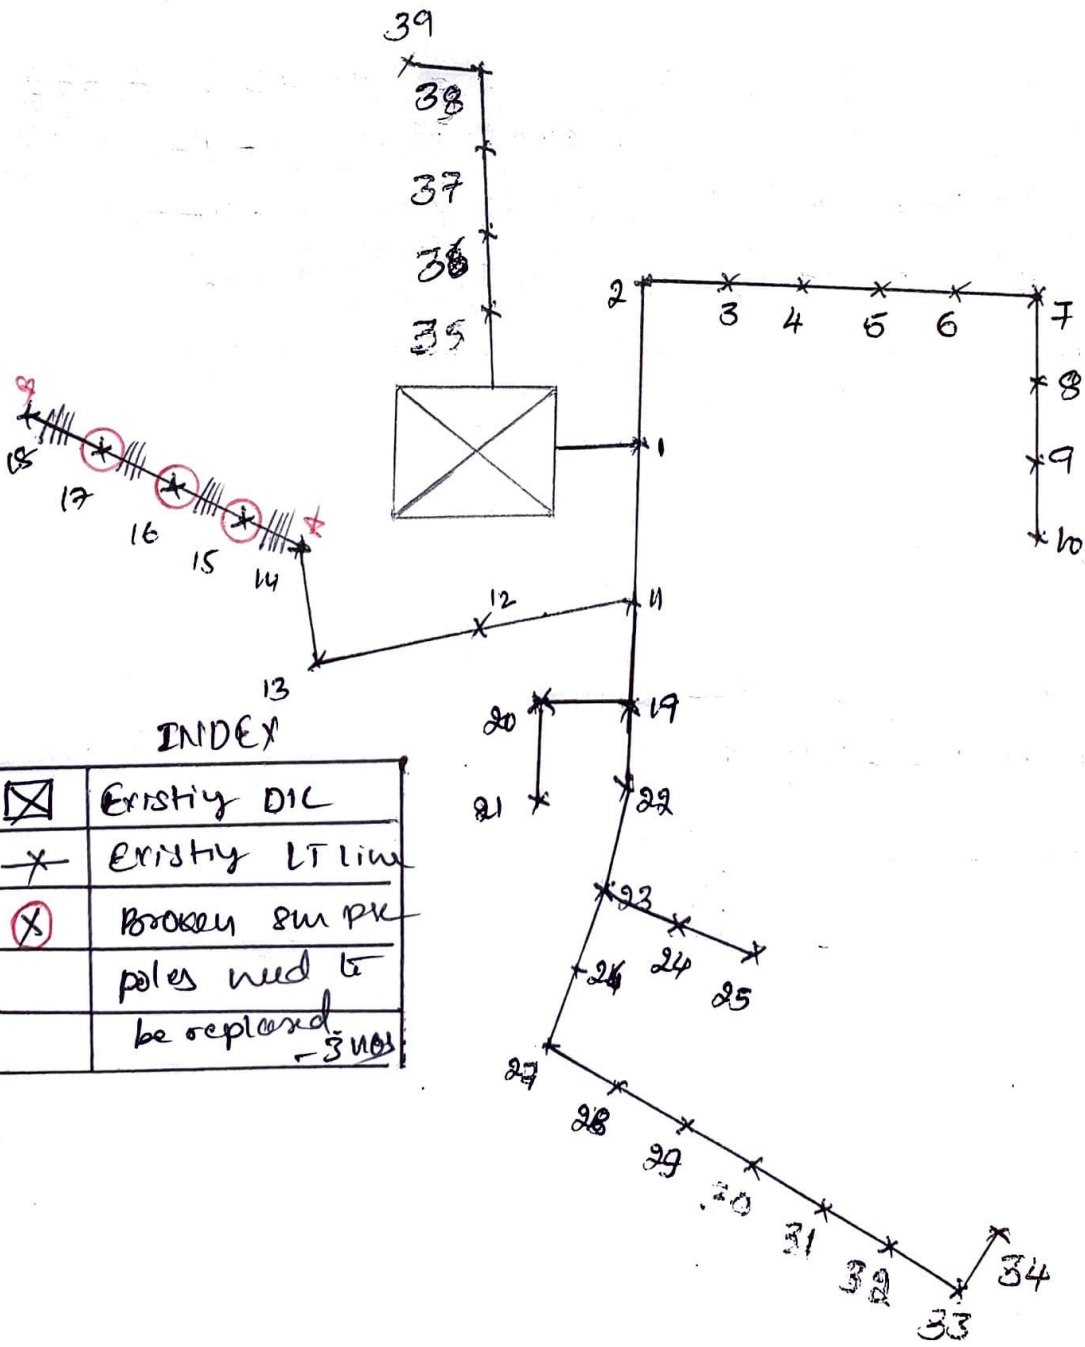
MAGASAVARA, BAKRAVALI ROAD 63 KVA

— X —	Existing HT Line
☒ X	Broken pole need to replaced - 9m RCC pole
— A — B	Proposed releasing & Restraining of conductor

☒	Existing DIC
-x	Existing LT line
⊗	Broken sum pole
	poles need to be replaced
	3 nos
